CF6-50

LPT Blade Stage 1 - 4

LPT Blade Seal Serration Modification – SB72-1254

Engine	CF6-50
Manual	-
Chapter	72-57-01
Repair	SB72-1254; LPT Rotor Blades – Modification – LPT Blade Shroud Seal Serration Modification.

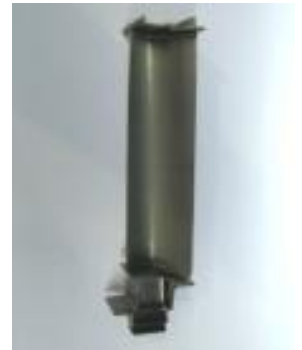
The CF6-50 LPT Blades do not have well defined leading edge contour tooth on the seal serrations. This may cause a wavy rub track in the LPT shroud honeycombs and in some cases causes the blades to contact a nozzle resulting in engine teardowns.

By application of this Service Bulletin (SB) repair accomplishment, the LPT blade's cutter teeth will eliminate the wavy rub tracks hence, reduce unnecessary tear downs.
