Commercial parts repair

V2500-A1 /-A5 /-D5, HPT duct segments stage 1 & 2 – full repair

An MTU^{Plus} repair solution

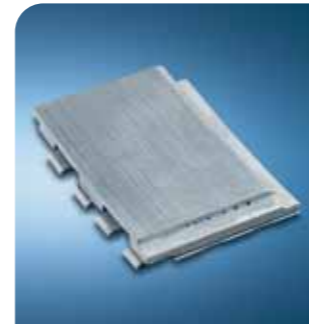
Air seal surface is restored.

In the full repair, firstly, the coating is removed from the outer duct segments and the cooling holes are brazed. Next, the air seal surface is restored and the abrasion resistant ceramic coating is applied. During this process, the cooling holes are restored using the latest laser drilling process.

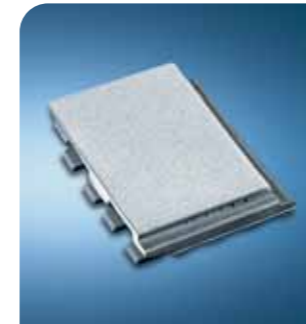
New coating is applied.

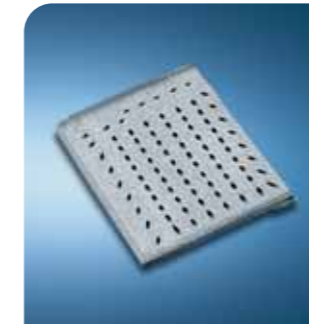
Cooling holes are redrilled by laser drilling.

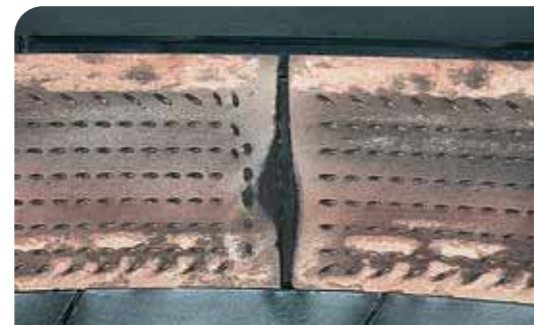
Typical incoming condition.
