# The Influence of Manufacturing Anomalies on Fatigue Performance of Critical Rotating Parts in the Aero-Engine

W. D. Feist<sup>1</sup>, F. Niklasson<sup>2</sup>, K. M. Fox<sup>3</sup>

## Abstract

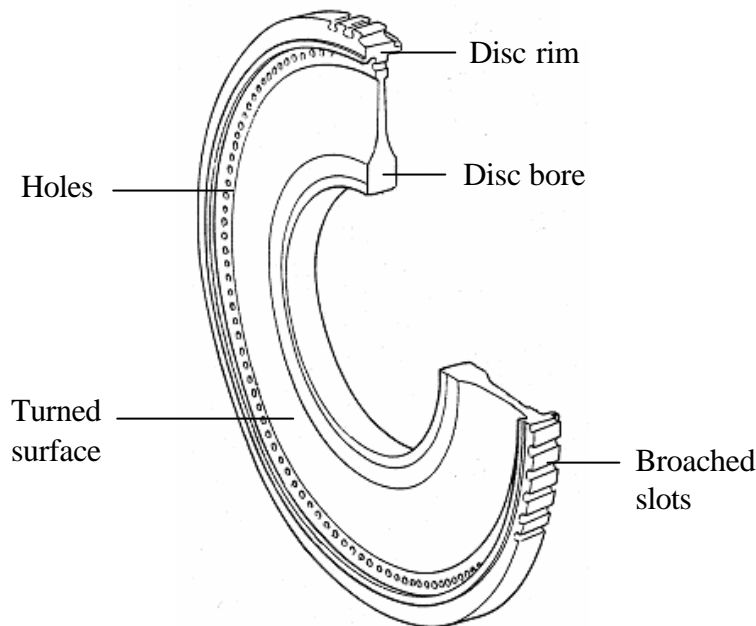
**Figure 1.** Schematic diagram to show nomenclature and typical features in gas turbine discs.

The work in MANHIRP is examining three features of a disc which together account for nearly 90% of all reported causes of manufacturing anomalies. A schematic diagram showing typical locations of the above features is shown in Fig. 1. These features are:

- (i) Turned surfaces, including the bore, diaphragm and drive arms.
- (ii) Holes, embracing those in the diaphragm, rim and in flanges.
- (iii) Broached slots in the rim of the disc.

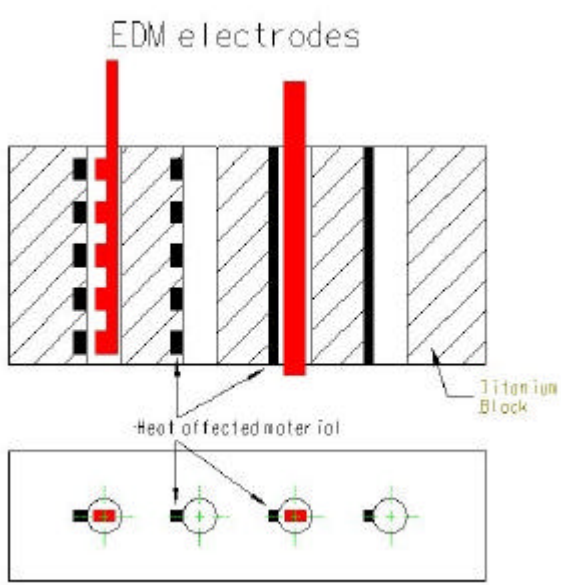
**Figure 2.** Point and line anomalies by EDM machining.

A series of specimens were produced at Volvo Aero from a Ti6Al4V disc forging to specification PWA1228. An artificial technique was used to introduce 'overheating' type of anomalies (anomaly type 1[1]). This was carried out using an Electro Discharge Machining (EDM) process. This method was used to produce point anomalies using a 0.8mm thick by 2mm wide copper electrode. The fatigue samples were produced from titanium blocks with the dimension 110 x 40 x 25 (mm). A hole of diameter 7.5mm was rough drilled in the centre of the block. The EDM anomalies were then produced in the hole (Fig. 2). The EDM electrode removed approximately 0.5 mm. After the EDM the hole was rough drilled to achieve a smooth surface and to remove most of the re-cast layer produced by the EDM machining. To improve the surface roughness the holes were honed to remove approximately a further 0.2 mm on the hole diameter. After the honing the titanium block was sliced by wire EDM into flat fatigue specimens and then ground to remove re-cast layer from the wire EDM. 'Datum' specimens were produced by drilling and honing alone.

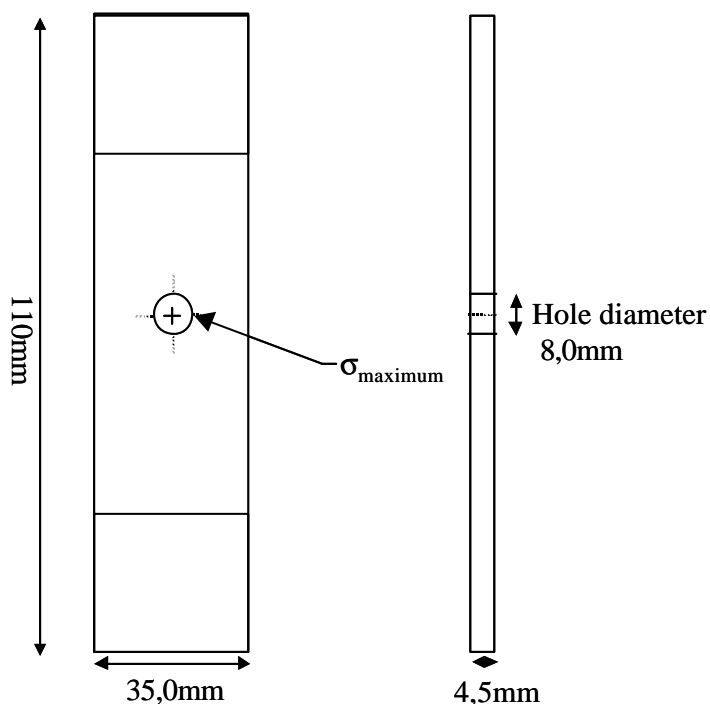
**Figure 3.** Schematic diagram of fatigue specimens used for hole feature testing.

The fatigue specimens were of the dimensions shown in Fig. 3. The peak stress at the hole was calculated using handbook formulae and compared to prediction from ANSYS modelling. Fatigue testing was carried out at room temperature at a frequency of 1Hz using an R ratio (where  $R = \text{maximum load}/\text{minimum load}$ ) of 0.1 and a sinusoidal waveform under load control. Fatigue testing was carried out using both an MTS and an INSTRON servo-hydraulic machine both with 100kN load cells and fitted with MTS647 hydraulic wedge grips rated to 100kN. Specimens were tested at predominantly two stress levels in order to establish scatter.

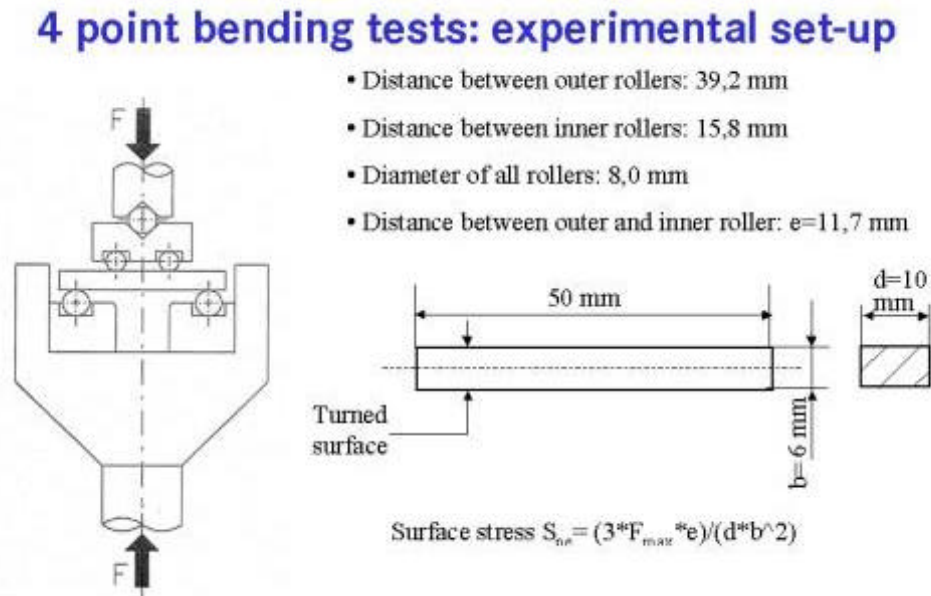
**Figure 4.** Fatigue testing set up used for 4 point bend testing

A series of specimens were produced by MTU using Ti6Al4V disc forging material to specification PWA1228. The specimens were machined from discs turned using similar turning parameters as specified in 2.2.1. The specimens were all tested according to the set up and details given in Fig. 4.

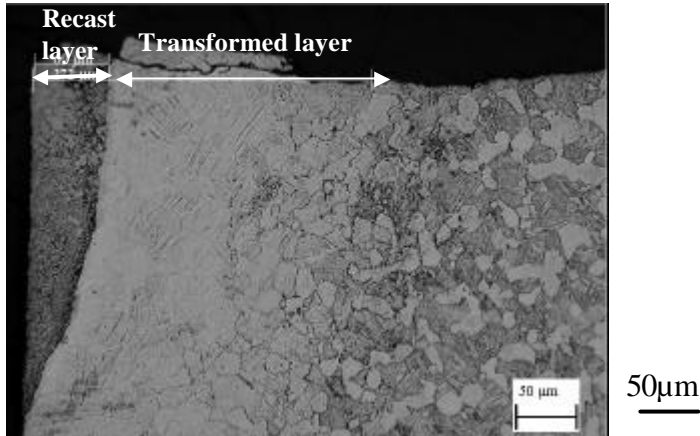
**Figure 6.** Micrograph of overheated area taken through fracture surface of specimen tested at normalised stress of 0.875 which failed at 34,971 cycles.

transformed beta microstructure (see Fig. 6). At the very surface a recast layer is formed, and varying amounts of this layer remain after honing of the hole. If the total depth of overheated material is measured, there is some correlation between a larger depth of overheated material with a lower cyclic life of the specimen, particularly at the higher stress level employed.

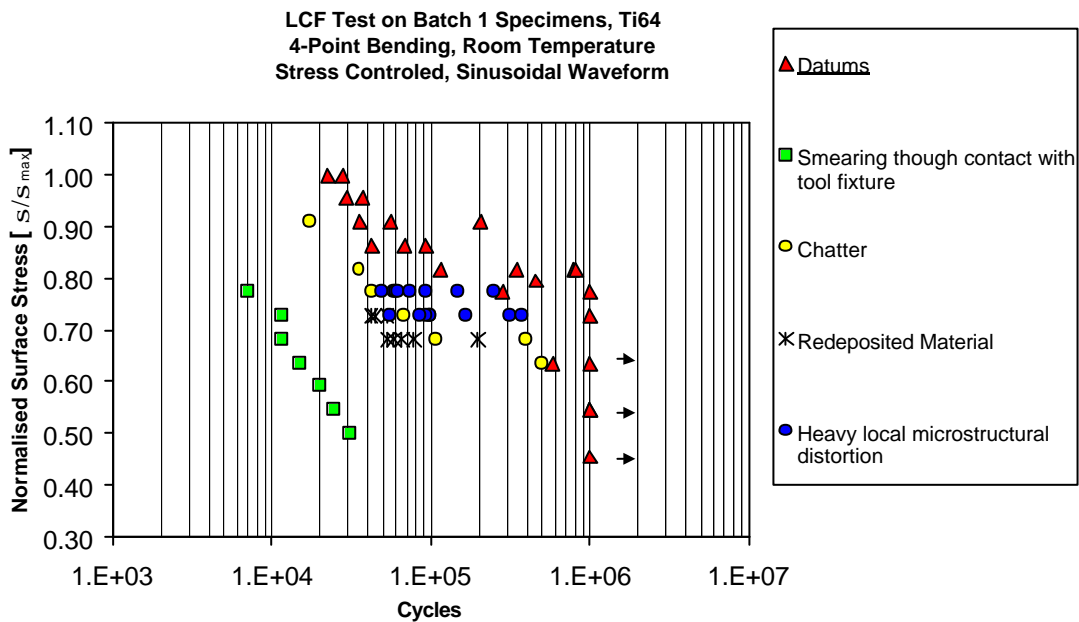
**Figure 7.** Low cycle fatigue results from turned specimens in Ti-6Al-4V.

Results of the fatigue testing are shown in Fig. 7.

The datum specimens can be seen to exhibit fairly typical S-N type behaviour.

Redeposited material can be seen to reduce the fatigue strength below that of the datum specimens. In some cases, fatigue crack initiation started from smearing features (see Fig. 9), but in other cases initiation started from 'scratch' like features which were associated with the smeared material due to the artificial method used to create the redeposited material.

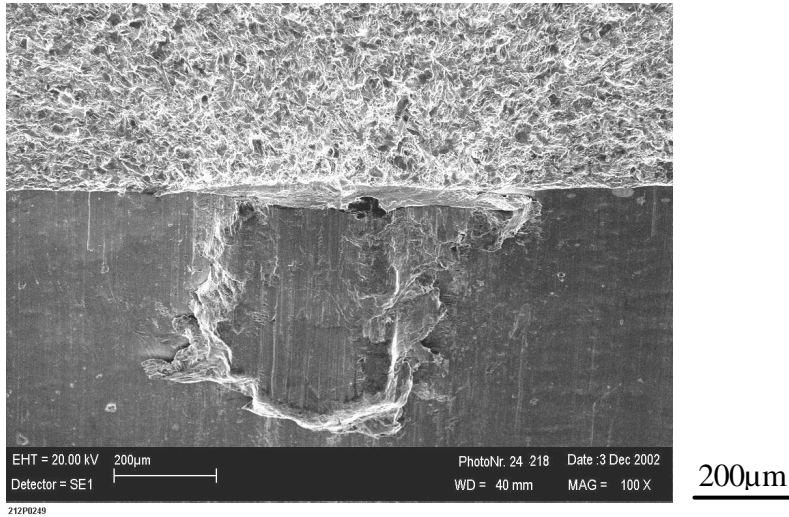
**Figure 9.** Fatigue crack initiation site associated with redeposited material.

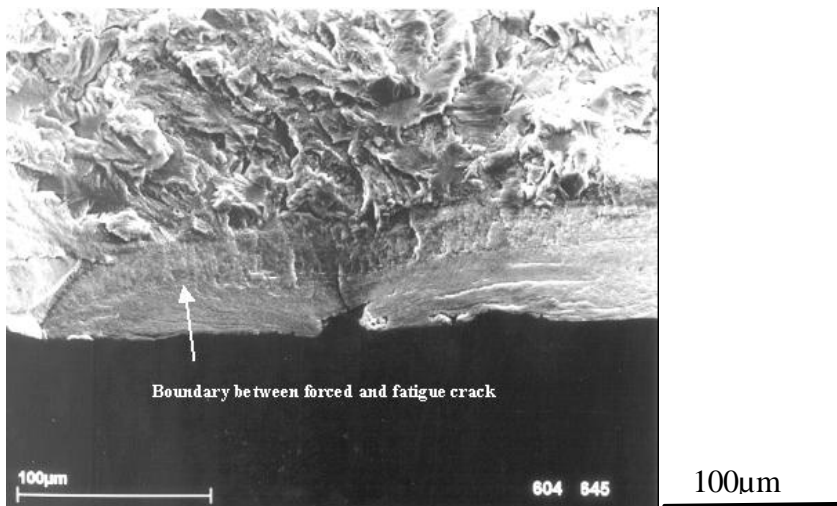
**Figure 10.** Scanning electron microscope image showing fracture surface, where heavily distorted microstructure showing boundary between 'forced' pre-crack (present prior to fatigue testing) and fatigue crack growth during fatigue testing.

Examination of the specimens after fatigue testing revealed that pre-cracks existed in the smeared material even prior to fatigue cycling and therefore fatigue life consisted of crack propagation only (Fig. 10). This explains the very large debit on fatigue strength caused by this anomaly.
